3-YEAR ASBESTOS RE-INSPECTION REPORT

WEST SCRANTON INTERMEDIATE SCHOOL SCRANTON, PA

**SCRANTON SCHOOL DISTRICT
425 North Washington Avenue
Scranton, Pa. 18505**

PROJECT: #SSD.19_751

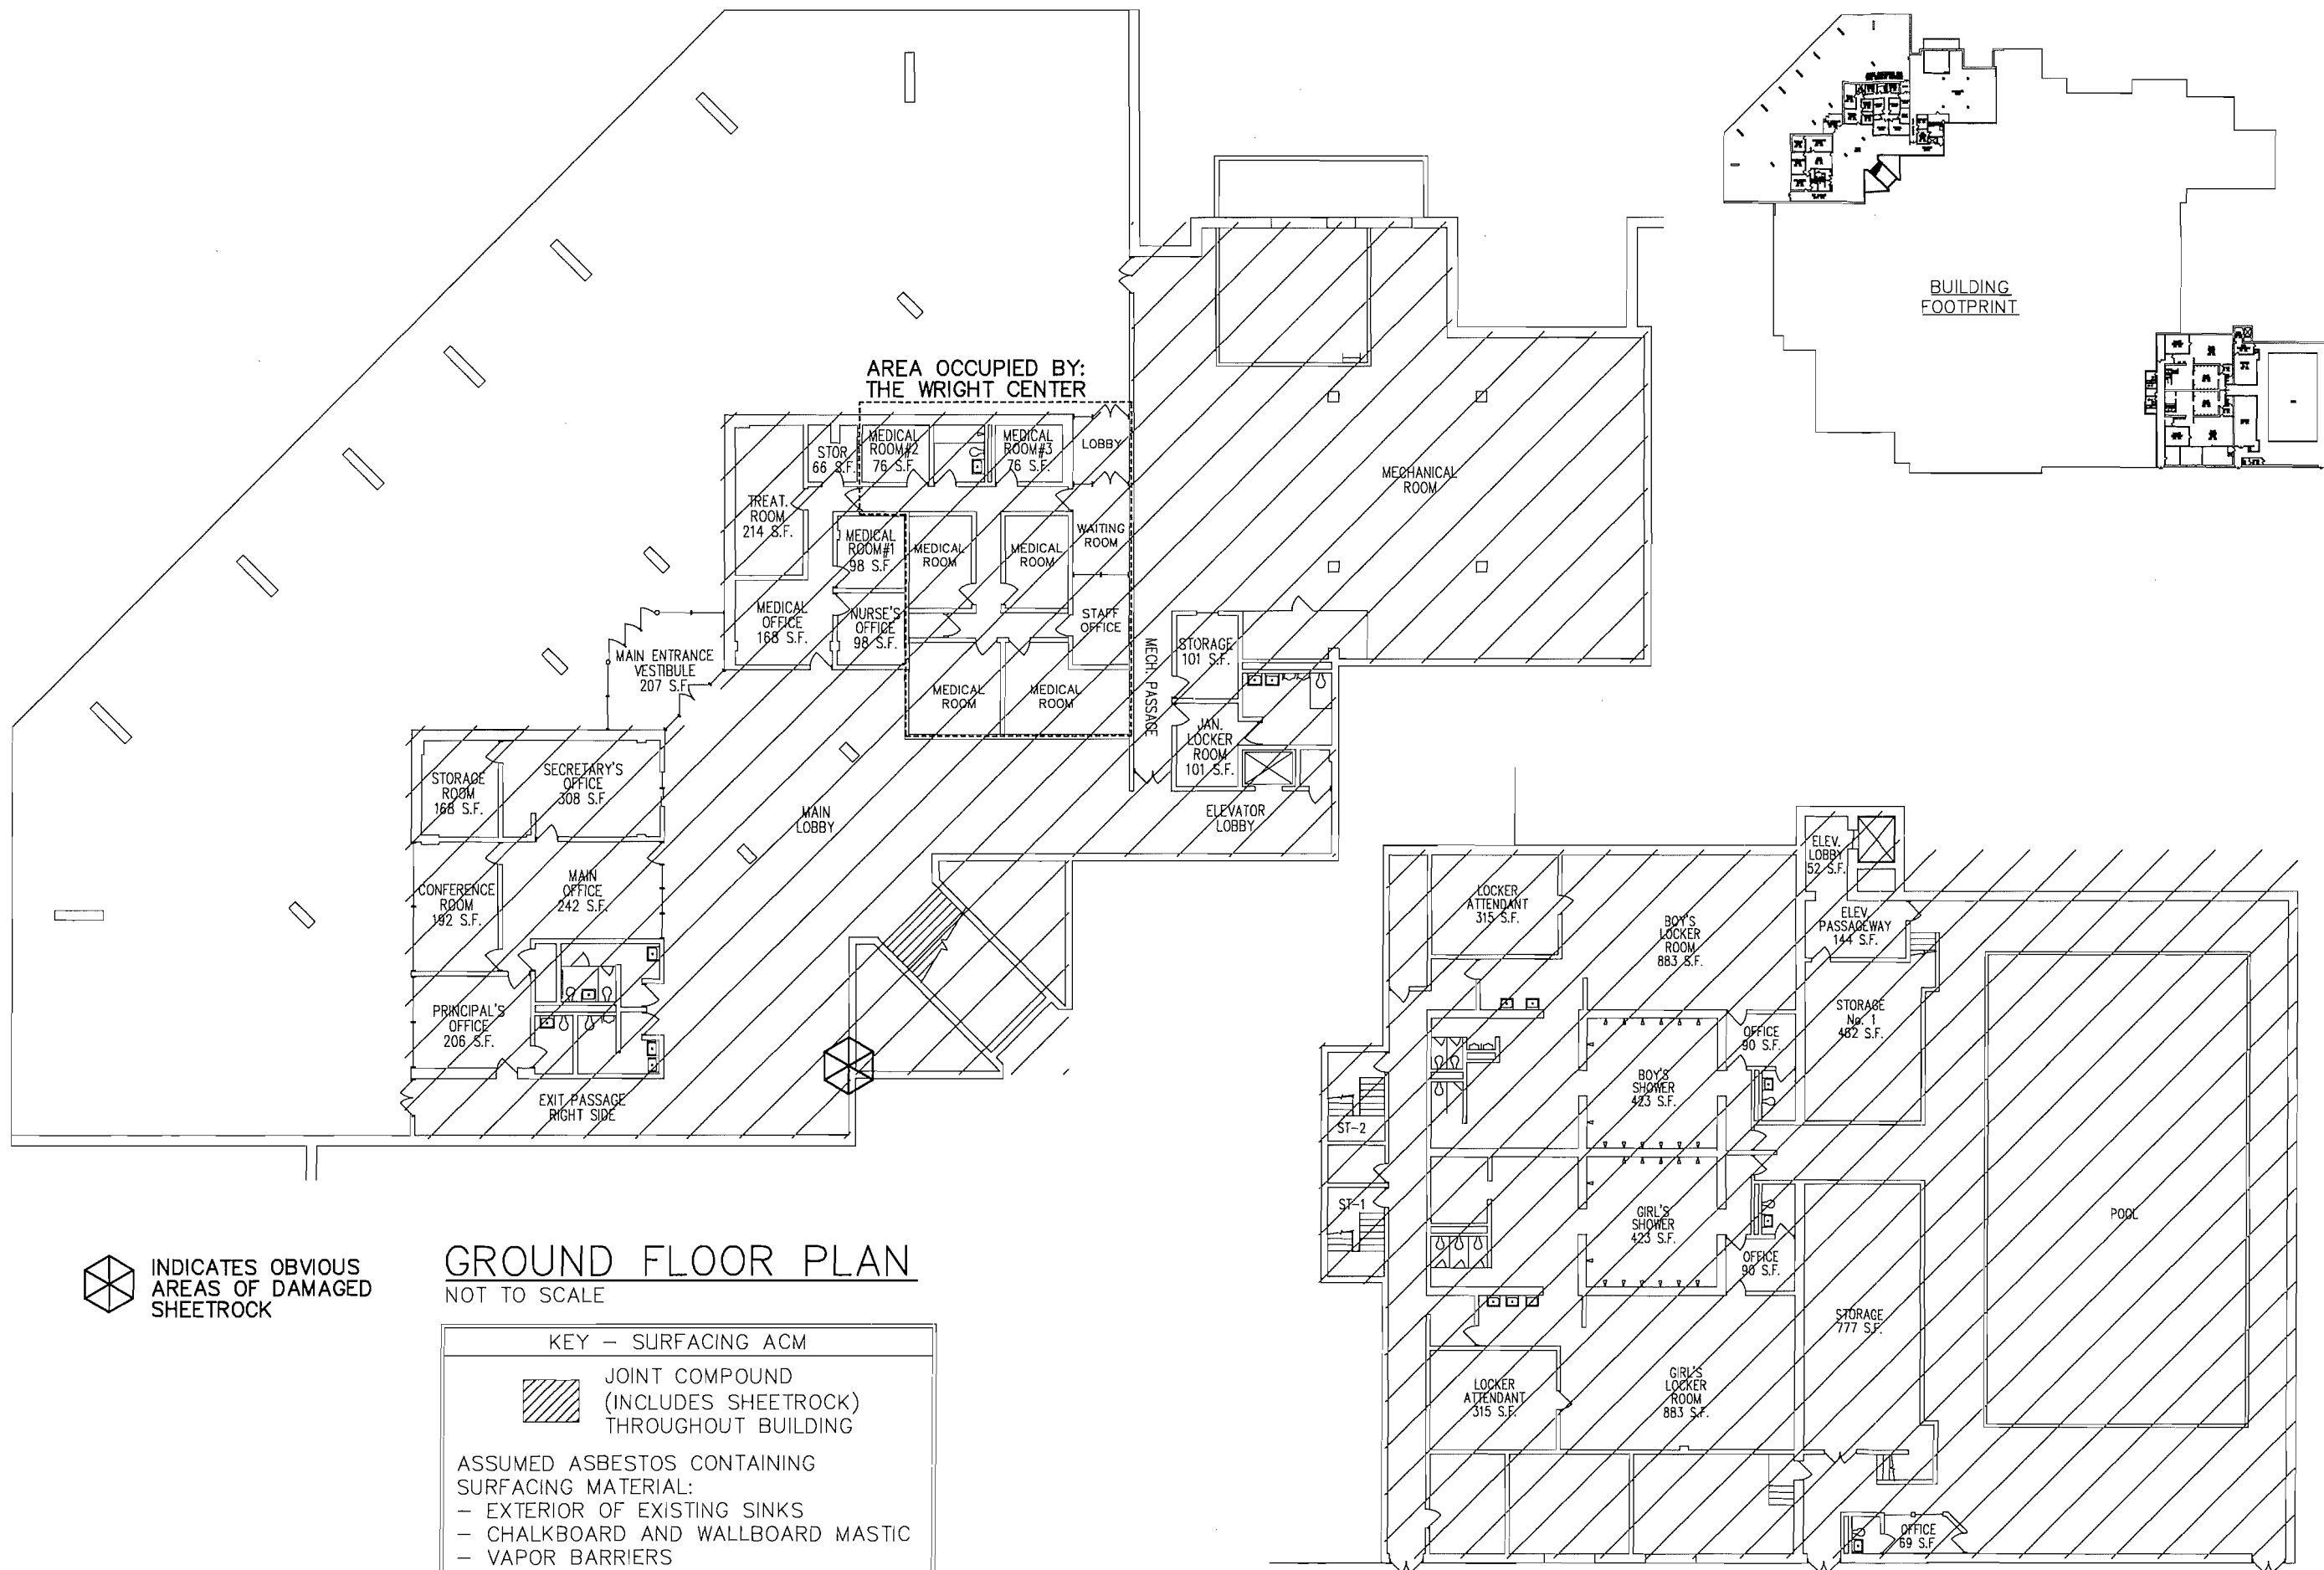
DRAWING No.:
A
1

INDICATES OBVIOUS
AREAS OF DAMAGED
SHEETROCK

JOINT COMPOUND
(INCLUDES SHEETROCK)
THROUGHOUT BUILDING

ASSUMED ASBESTOS CONTAINING
SURFACING MATERIAL:
- EXTERIOR OF EXISTING SINKS
- CHALKBOARD AND WALLBOARD MASTIC
- VAPOR BARRIERS
- MASTIC UNDER WOOD RAILINGS

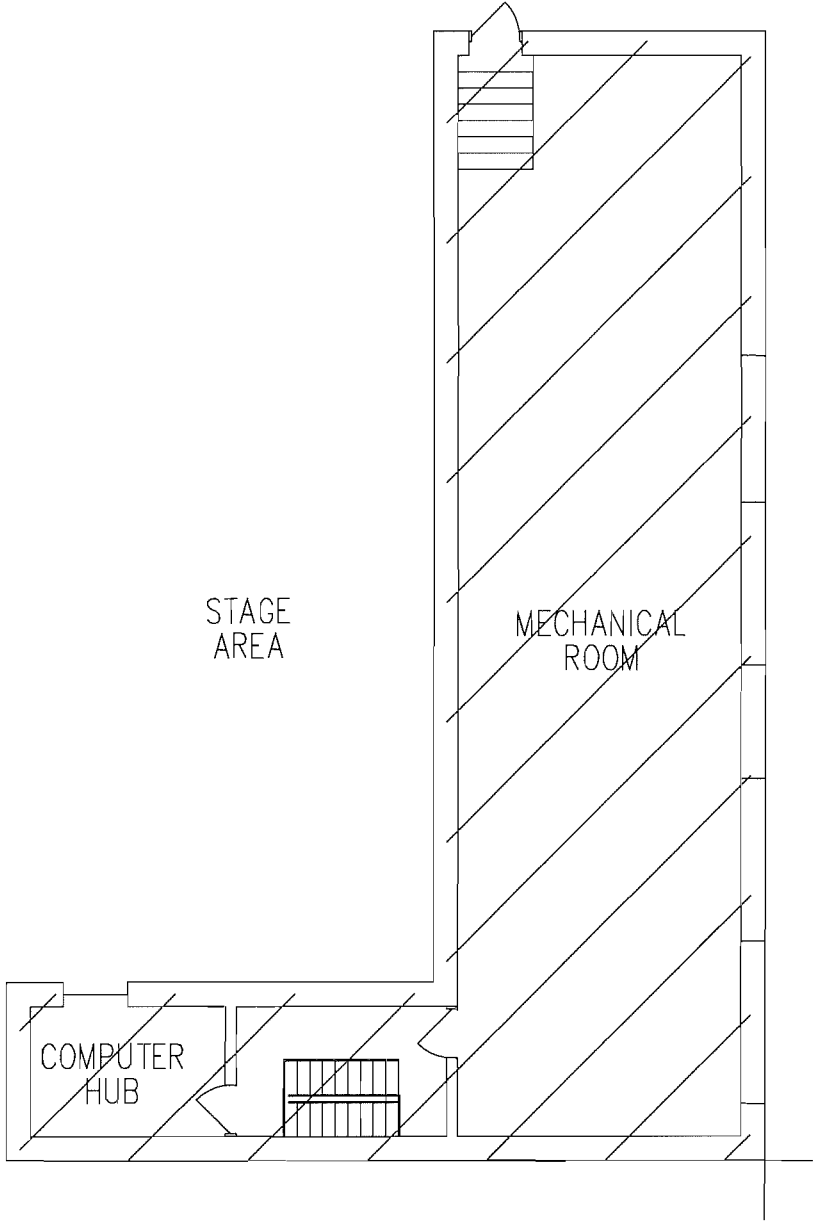
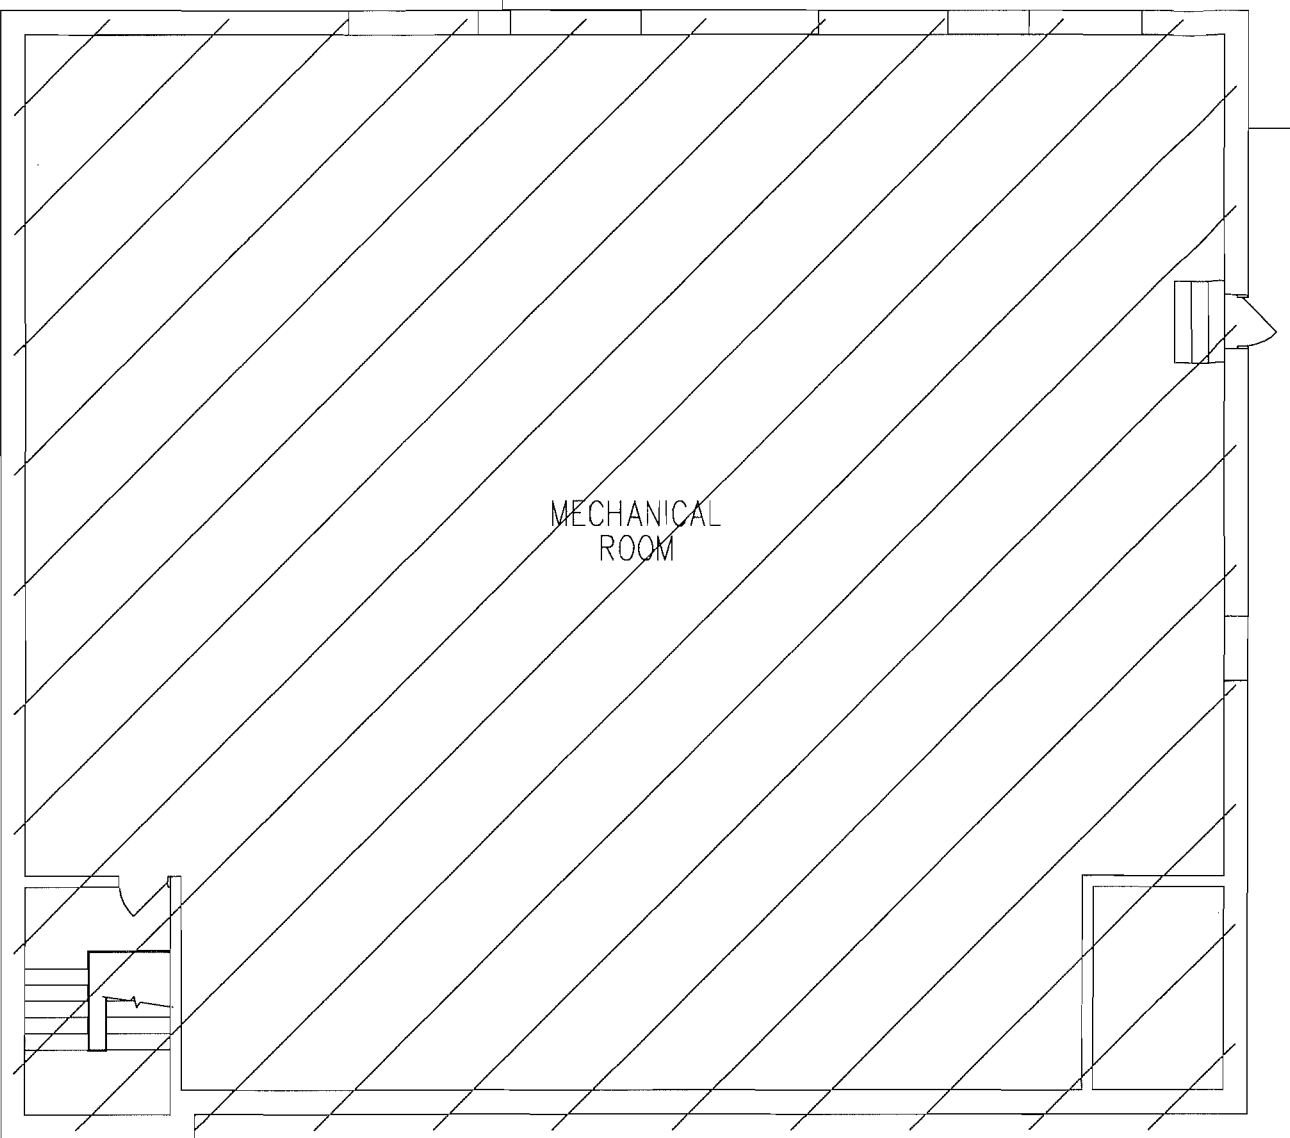
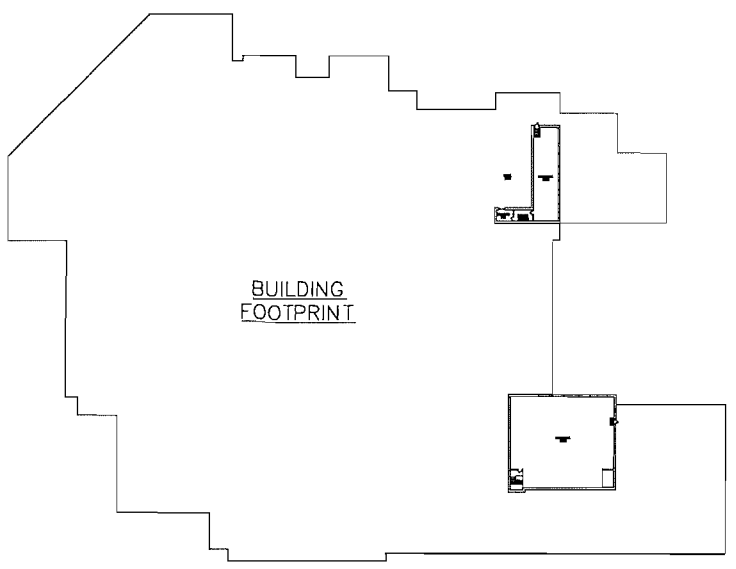
DRAWING No.: **A3**

JOINT COMPOUND
(INCLUDES SHEETROCK)
THROUGHOUT BUILDING

ASSUMED ASBESTOS CONTAINING
SURFACING MATERIAL:

- EXTERIOR OF EXISTING SINKS
- CHALKBOARD AND WALLBOARD MASTIC
- VAPOR BARRIERS
- MASTIC UNDER WOOD RAILINGS

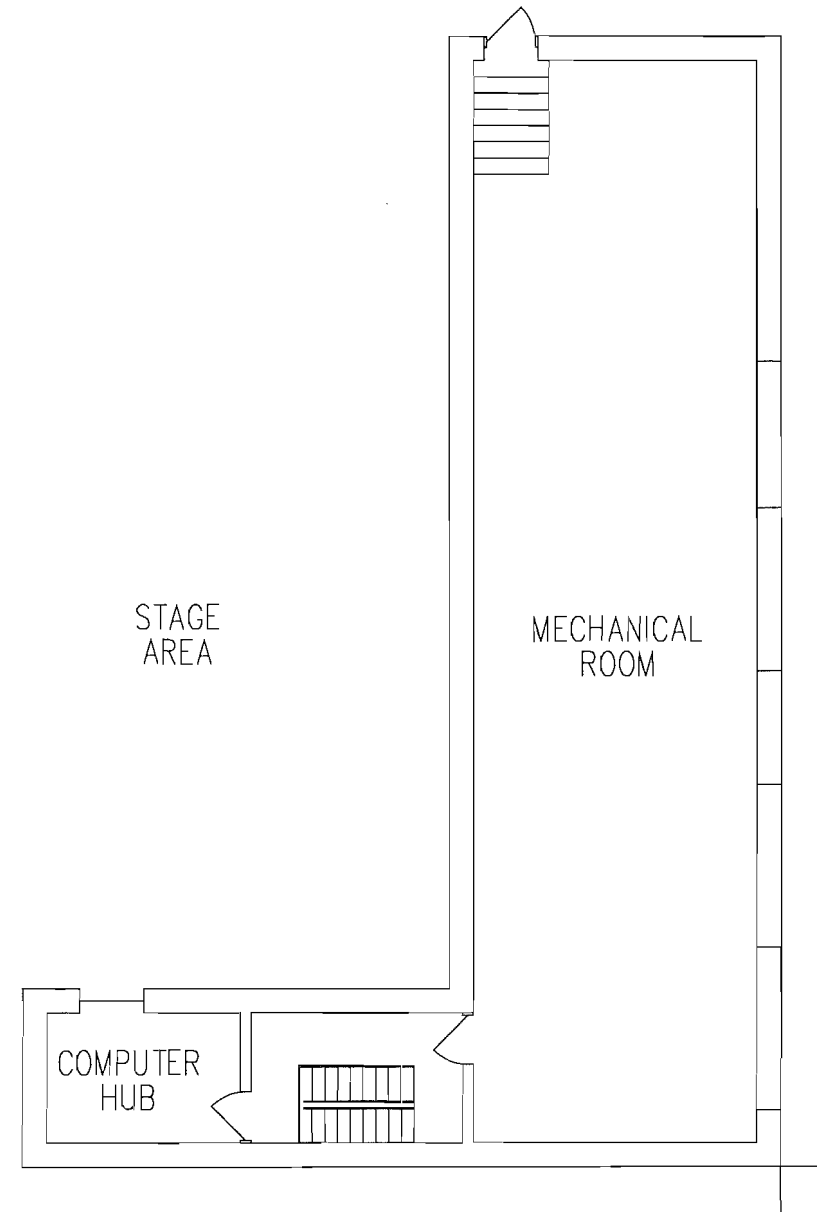
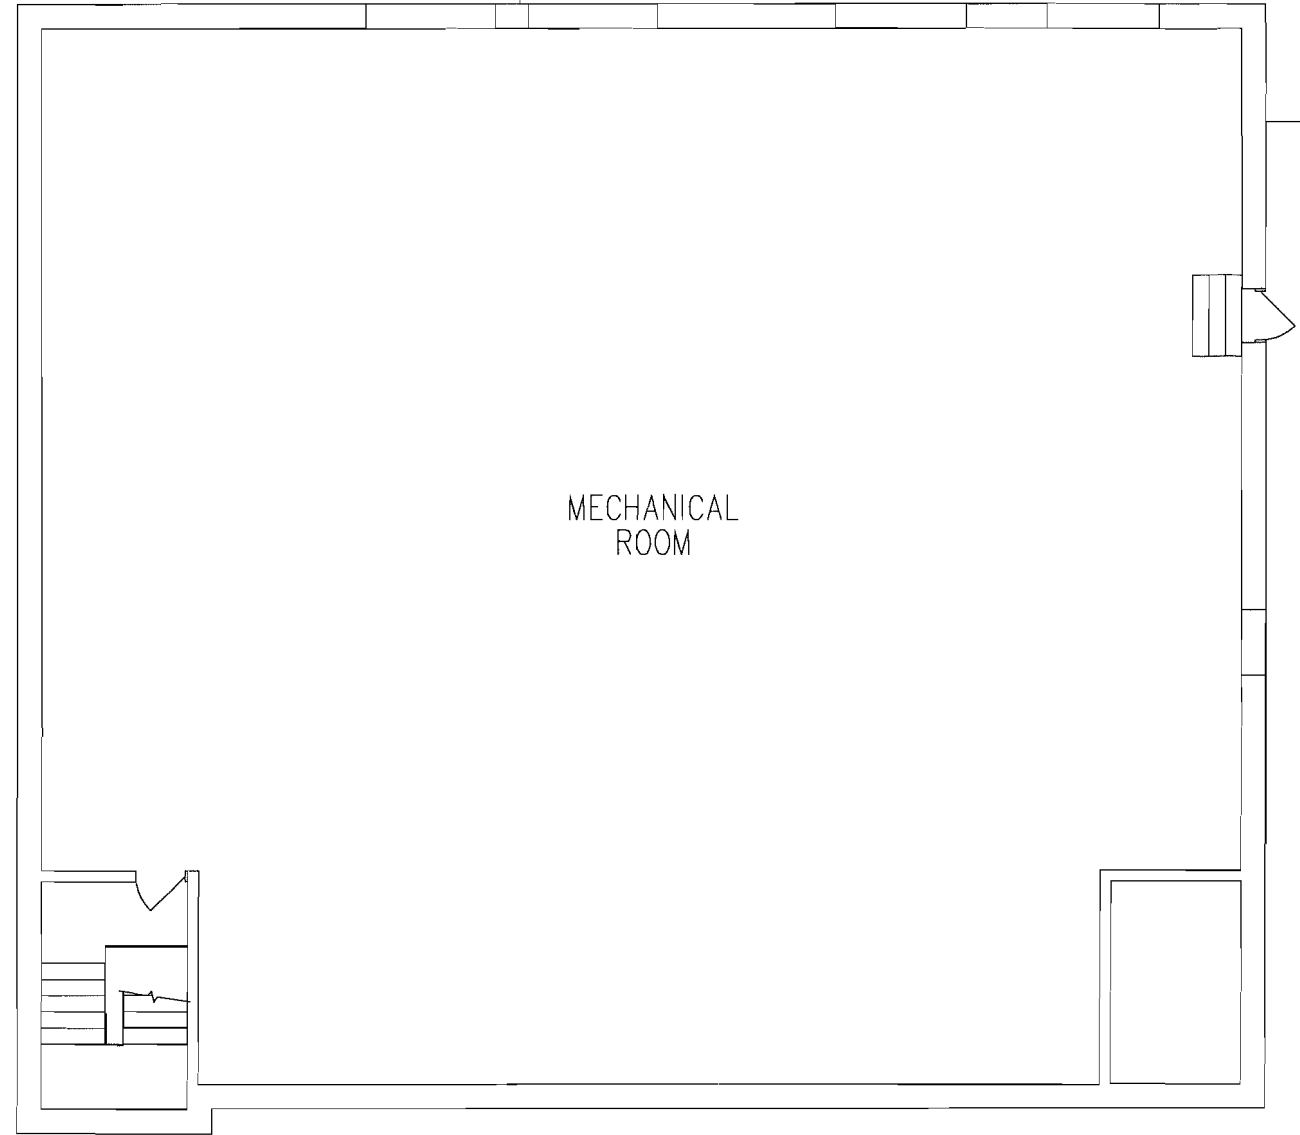
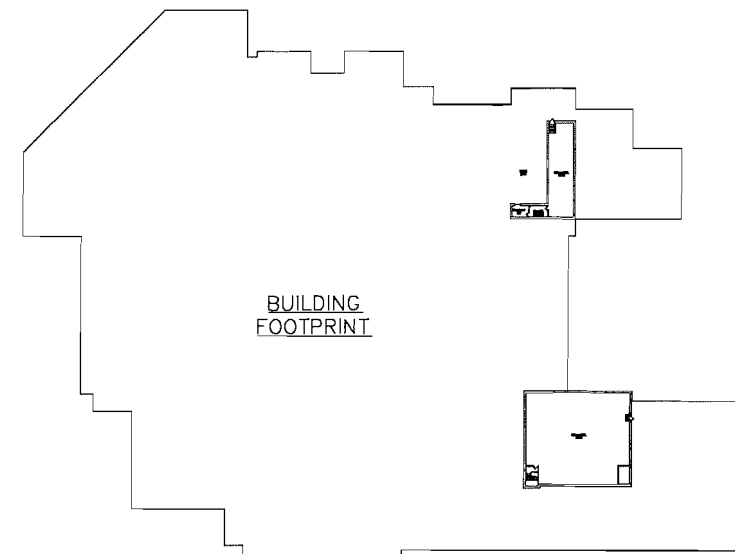
DRAWING No.: **A**
6

NO THERMAL SYSTEM INSULATION (TSI) WAS FOUND ON THIS LEVEL

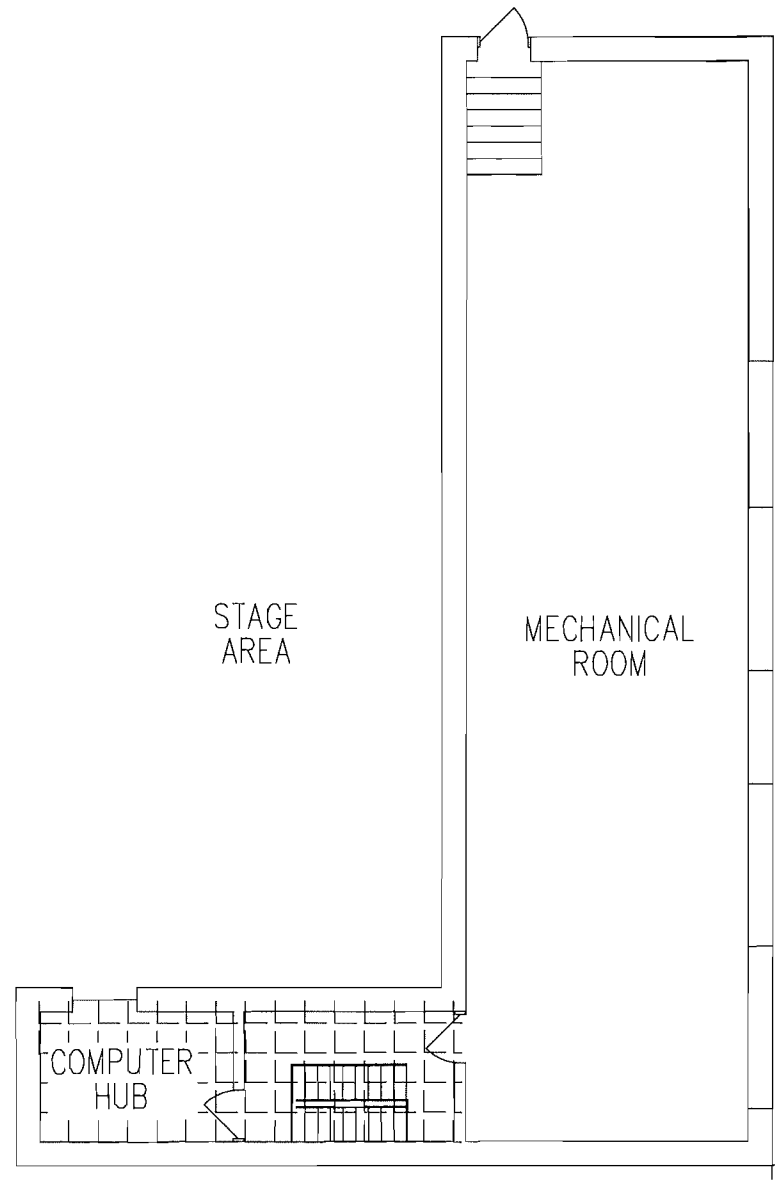
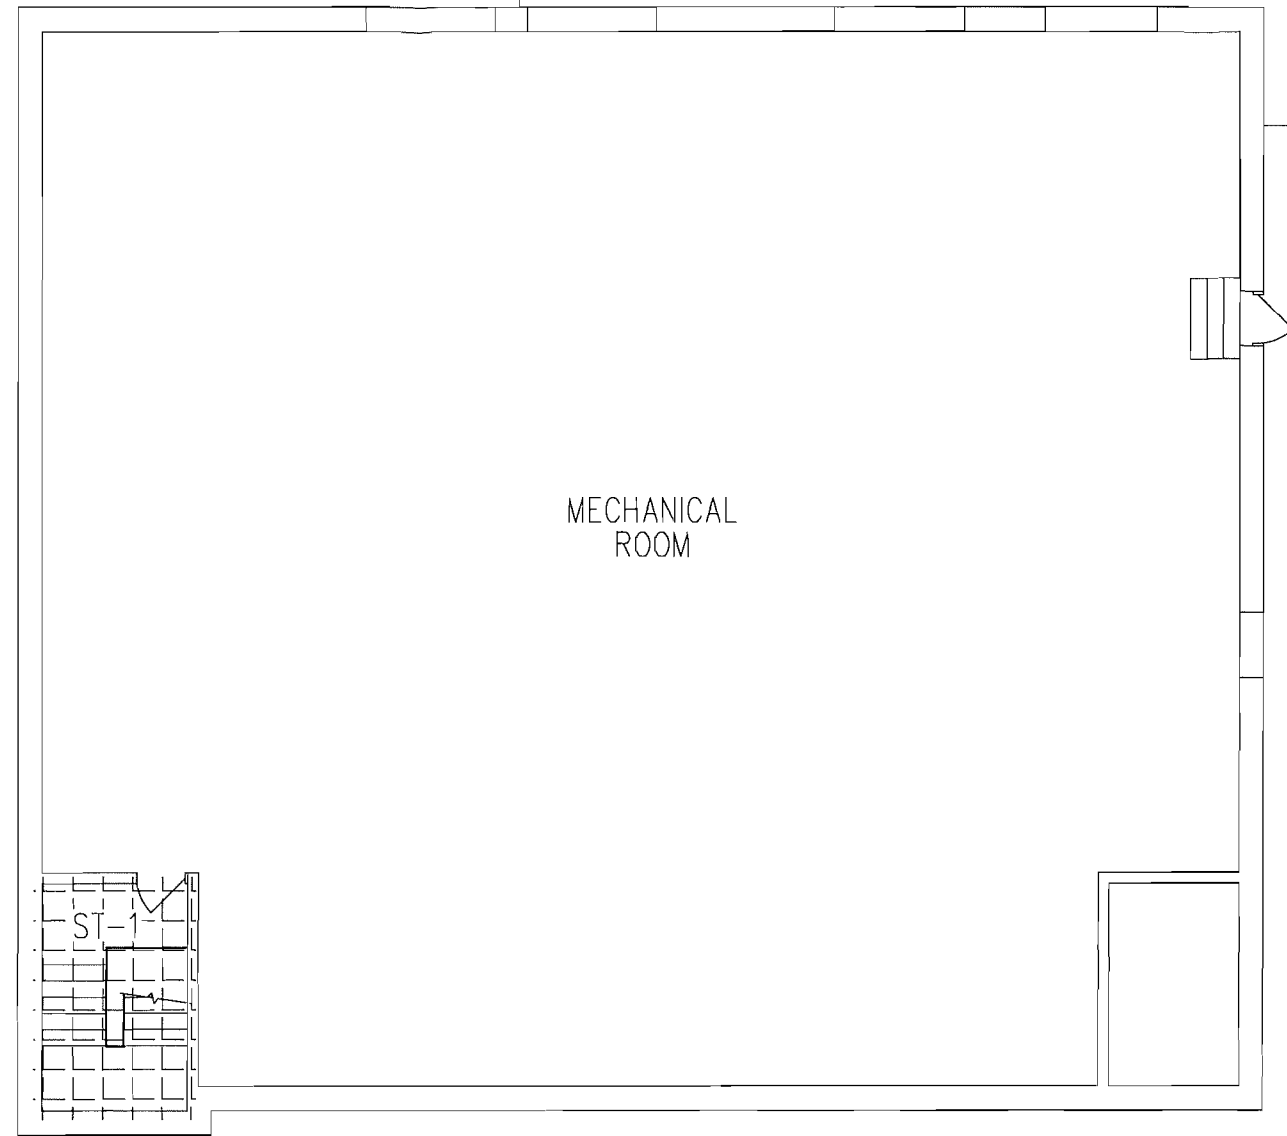
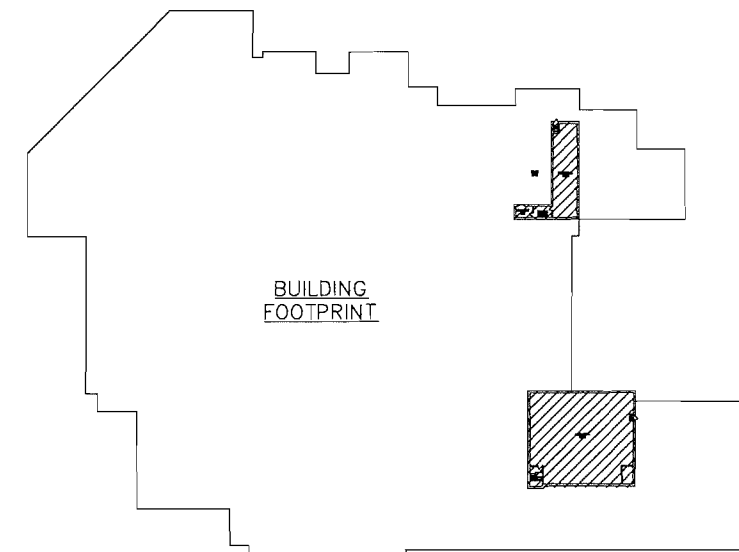
DRAWING No.: **A**
9

12"x12" FLOOR TILE & MASTIC
ASSUMED ASBESTOS CONTAINING SURFACING MATERIAL:	
- FLEX CONNECTIONS ON DUCT WORK
